New York State Department of Transportation

Yellow Flag NB2222W008

BIN: 1065318
Feature Carried: 278I278IX2M23027
Feature Crossed: 6TH AVENUE
Orientation: 8 - NORTHWEST
Region: 11 - NEW YORK CITY
County: KINGS
Political Unit: City of NEW YORK
Approximate Year Built: 1962
Posted Load Matches Inventory : Yes
Bridge Load Posting (Tons) : Not Posted for Load
Primary Owner: New York State Department of Transportation
Primary Maintenance Responsibility: 12 - State - Subcontracted to another Party
Typical or Main Span Type: 3 - Steel, 02 - Stringer/Multi-Beam or Girder
This Bridge is not a Ramp
Number of Spans: 322

Location: Span 255, Girder G1 at Pier 254

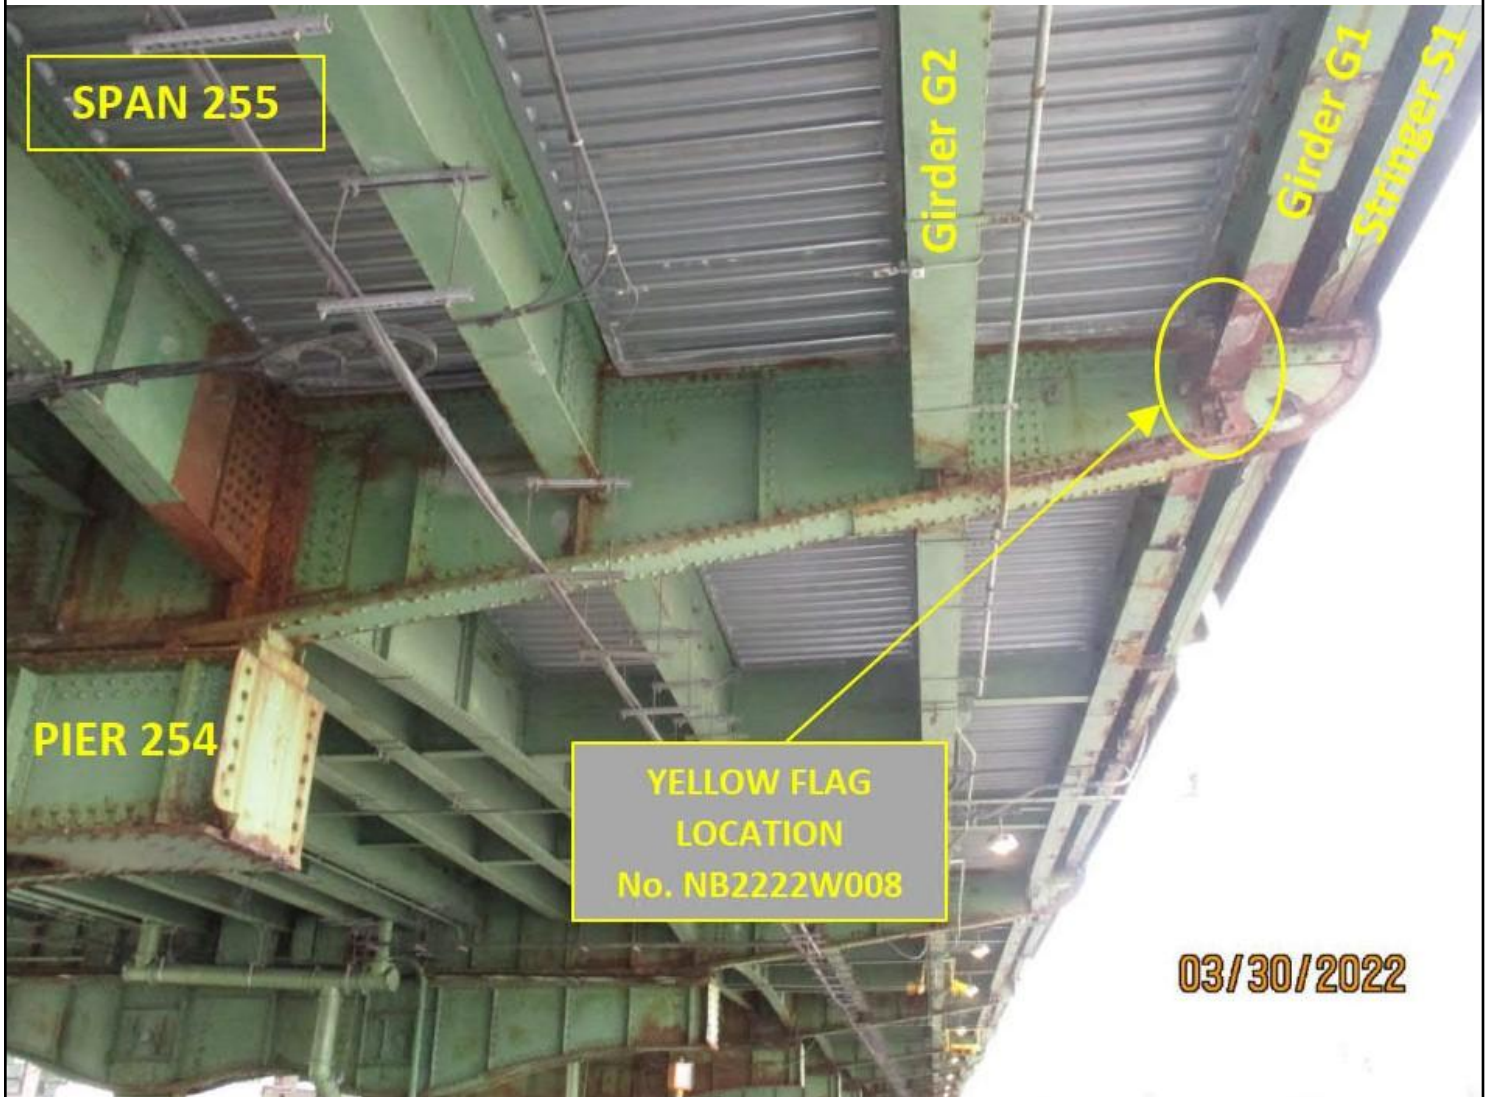
Photo Number: 1

Attachment Description: Photo 4668 – Span 255, Girder G1 at Pier 254. General view of the flagged location at pier cap connection. Looking begin.

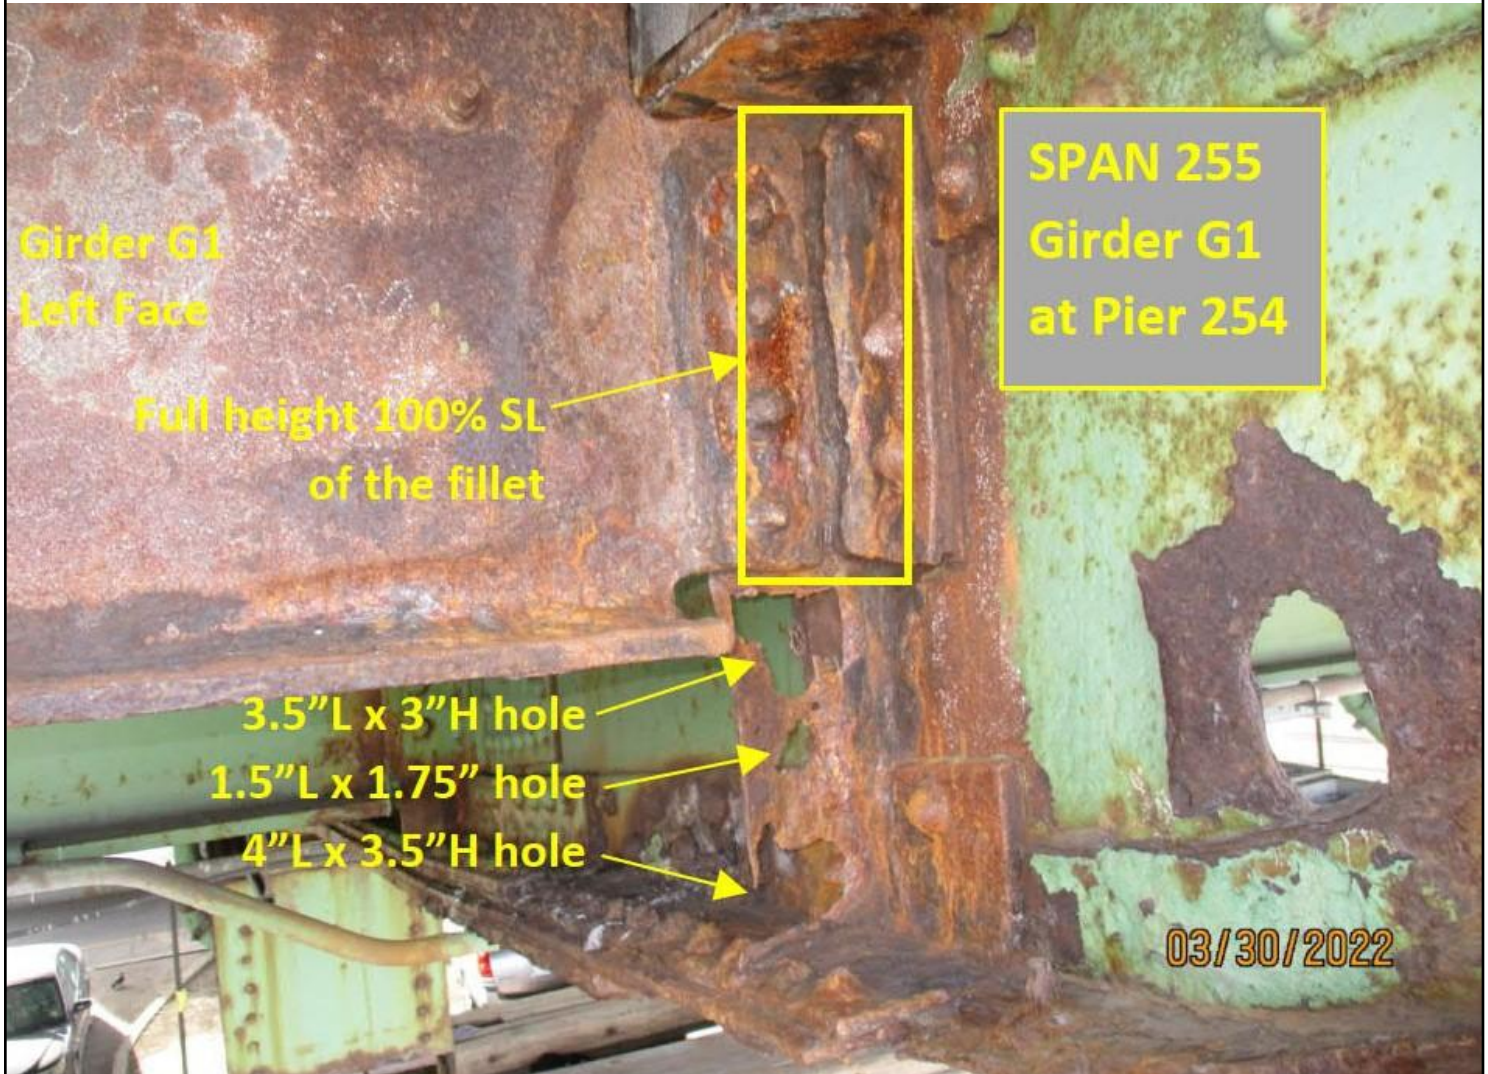
Photo Number: 2

- 2.The right connection angle exhibits three corrosion holes measuring 3.5"L x 3"H, 1.5"L x 1.75"H and 4"L x 3.5"H. The remaining height of the connection angle below Girder G1 exhibits up to 90% section loss. The right connection angle along the web of Girder G1 is in good condition.

Attachment Description: Photo 4644 – Span 255, Girder G1 at Pier 254. Close-up view of Girder G1 end showing heavy section loss to the web of the Girder and corrosion holes in the right connection angle. Looking begin right.

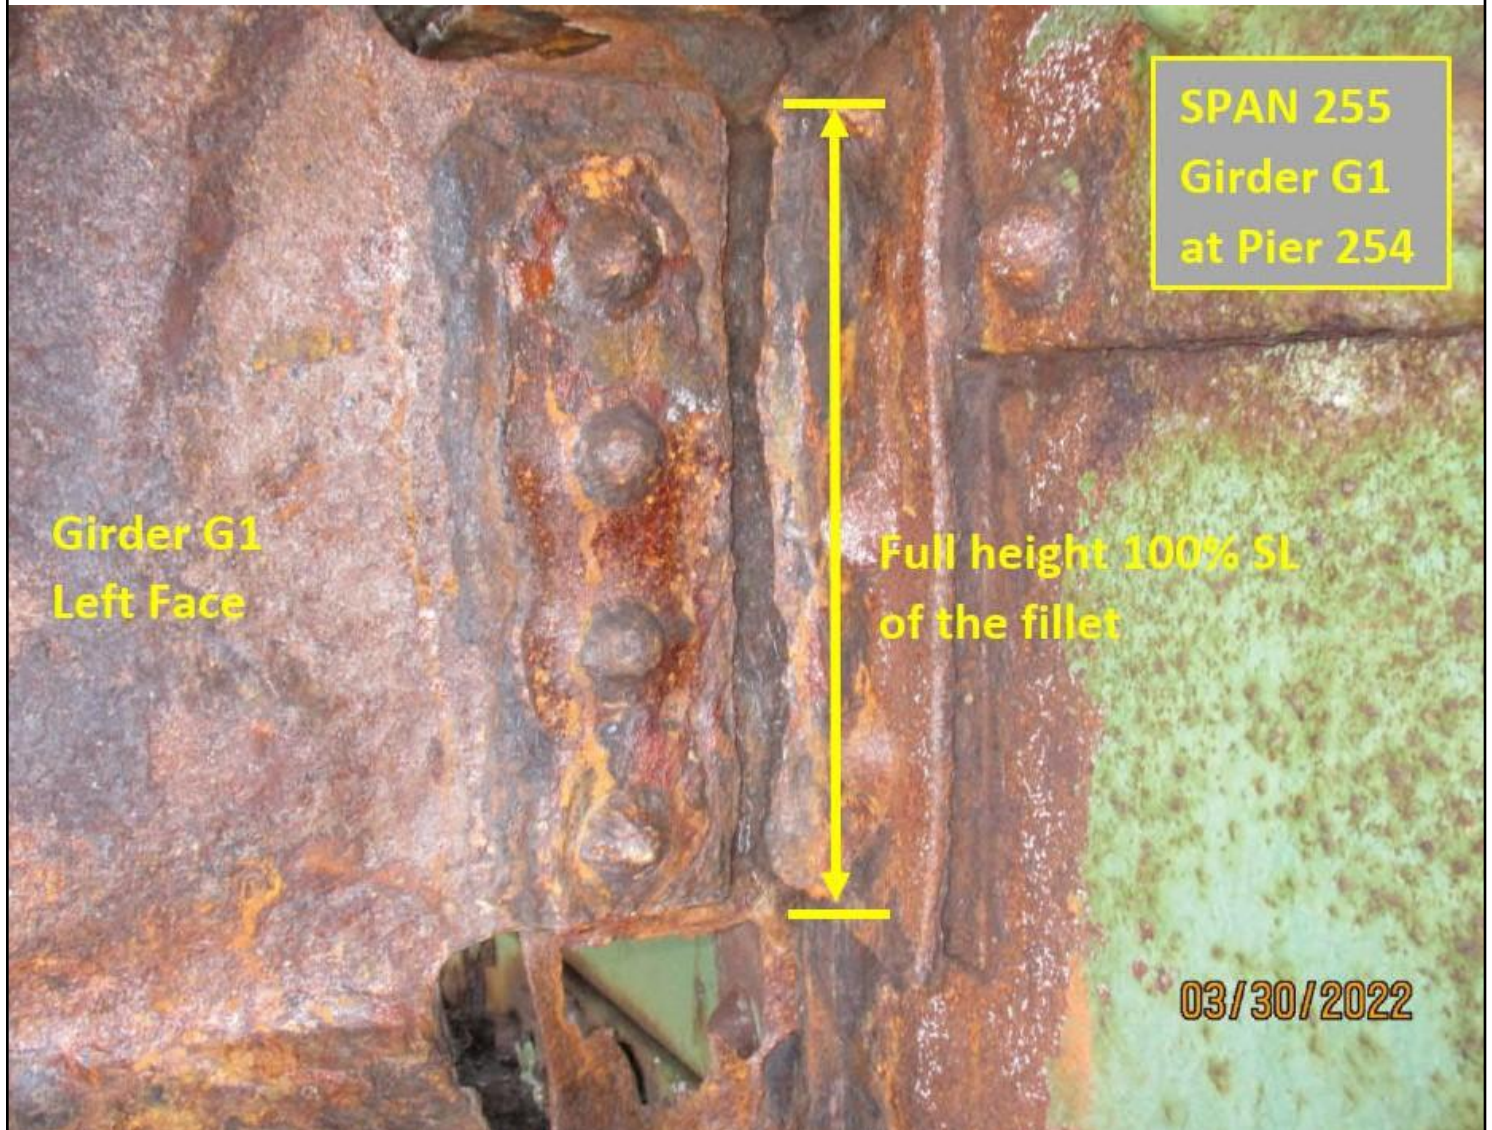
Photo Number: 3

Description: Girder G1 web along connection angle exhibits overall 55% section loss for full height (previously noted to be 56%). Additionally, the left connection angle exhibits full height 100% section loss along the fillet (same as previously noted).

Attachment Description: Photo 4651 – Span 255, Girder G1 at Pier 254. Close-up view of the full height 100% section loss along the fillet. Looking begin right.

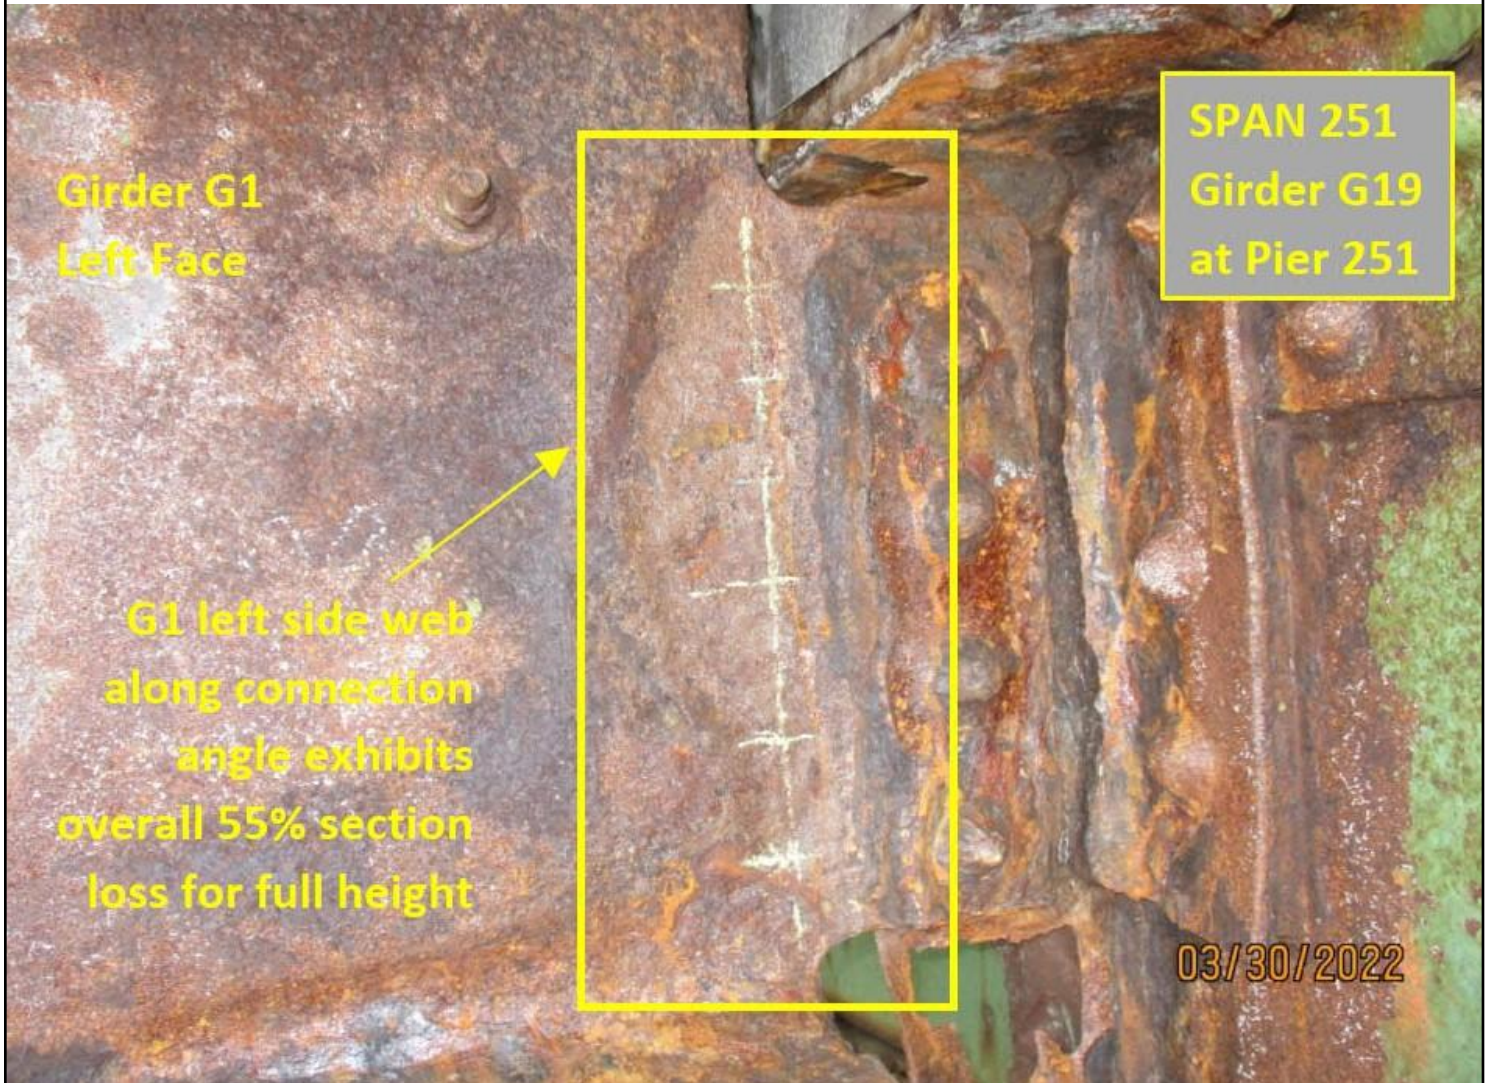
Photo Number: 4

Attachment Description: Photo 4658 – Span 255, Girder G1 at Pier 254. Close-up view of girder G1 left side web along connection angle exhibits overall 55% section loss for full height x 1-3” wide. Looking begin right.

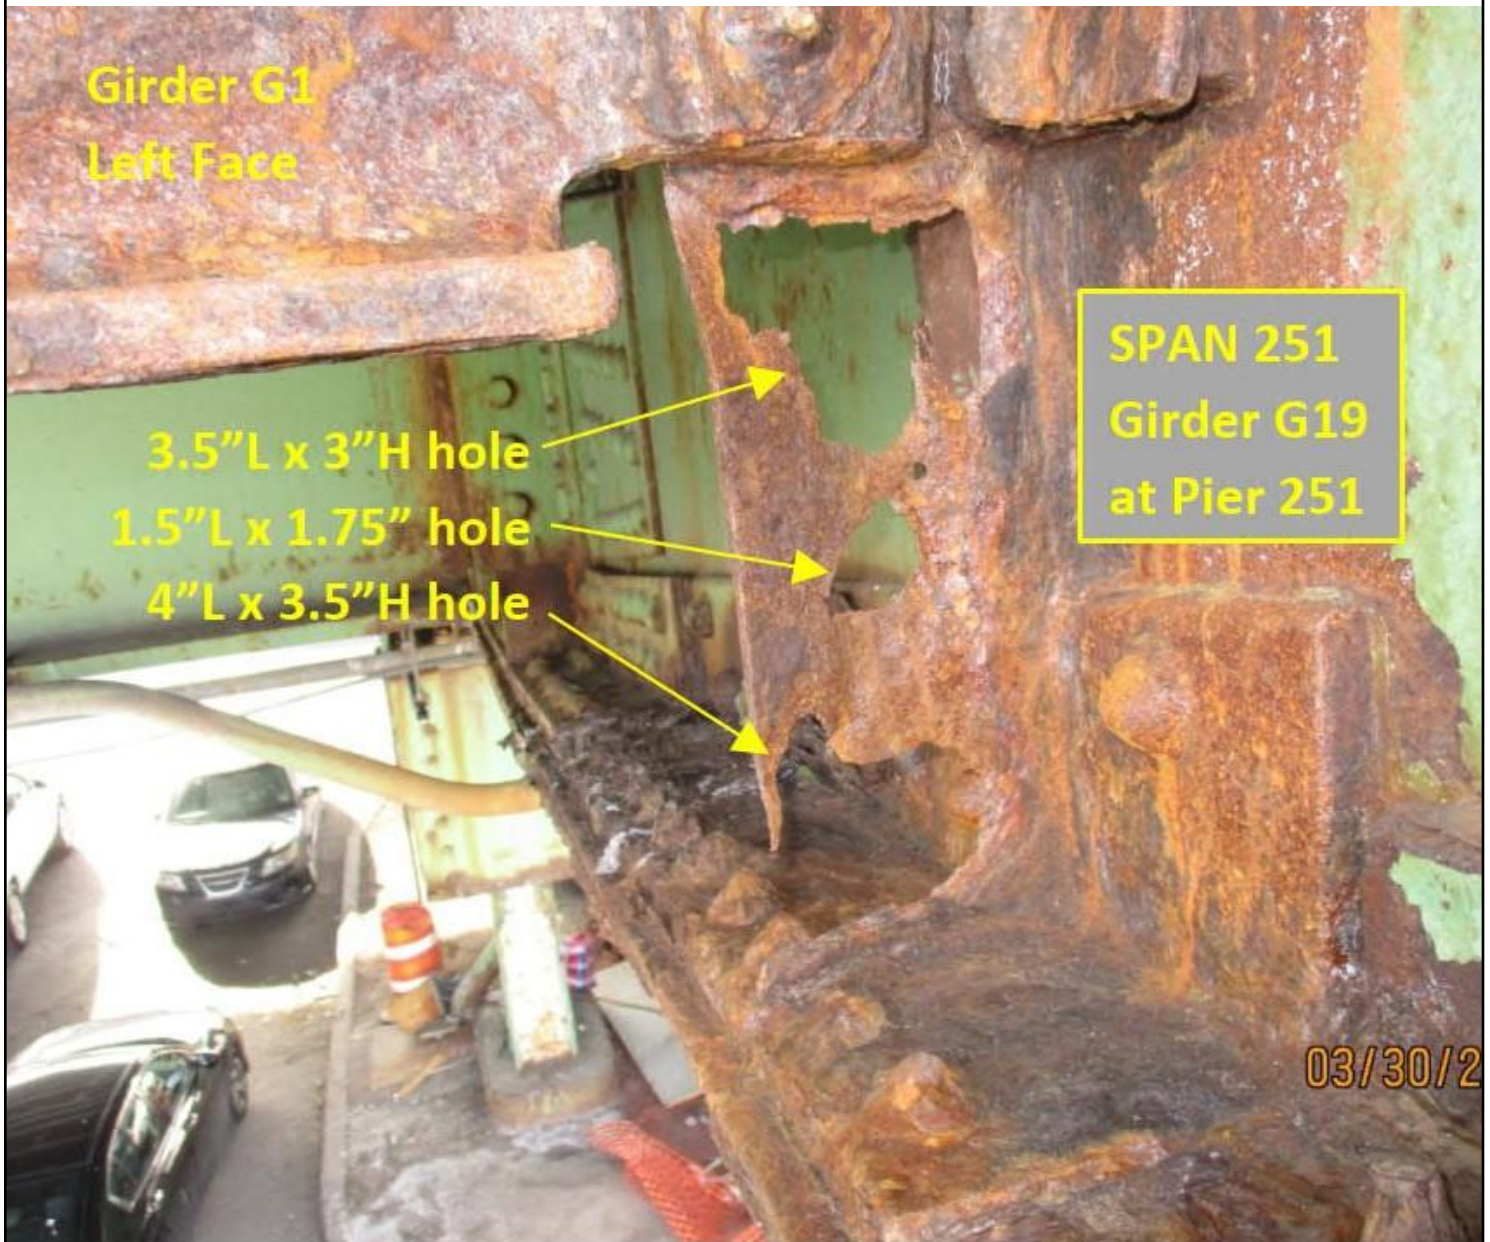
Photo Number: 5

Attachment Description: Photo 4647 – Span 255, Girder G1 at Pier 254. Close-up view of girder G1 right connection angle exhibits three corrosion holes measuring 3.5”L x 3”H, 1.5”L x 1.75”H and 4”L x 3.5”H. Looking right.

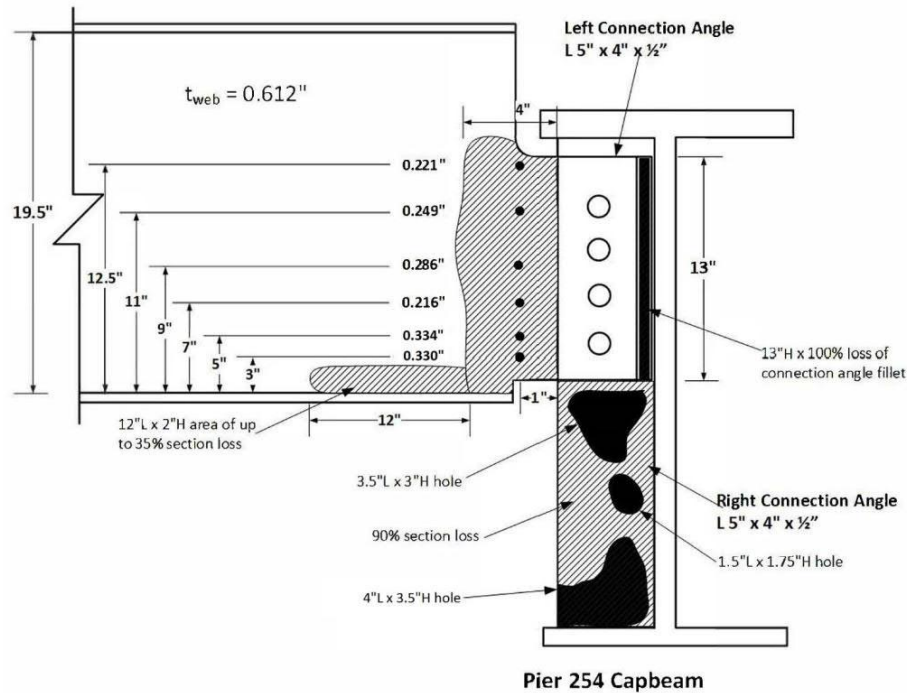
Photo Number: 6

Average remaining web section – $(0.221 + 0.249 + 0.286 + 0.216 + 0.334 + 0.330) / 6 = 0.273"$
 Web section loss – $(1 - (0.273 / 0.612)) \times 100\% = 55.39\%$ SAY = 55%

Span 255, Girder G1 at Pier 254
 (Looking Right)
 N.T.S

Attachment Description: SN 255 G1 at Pier 254 Sketch

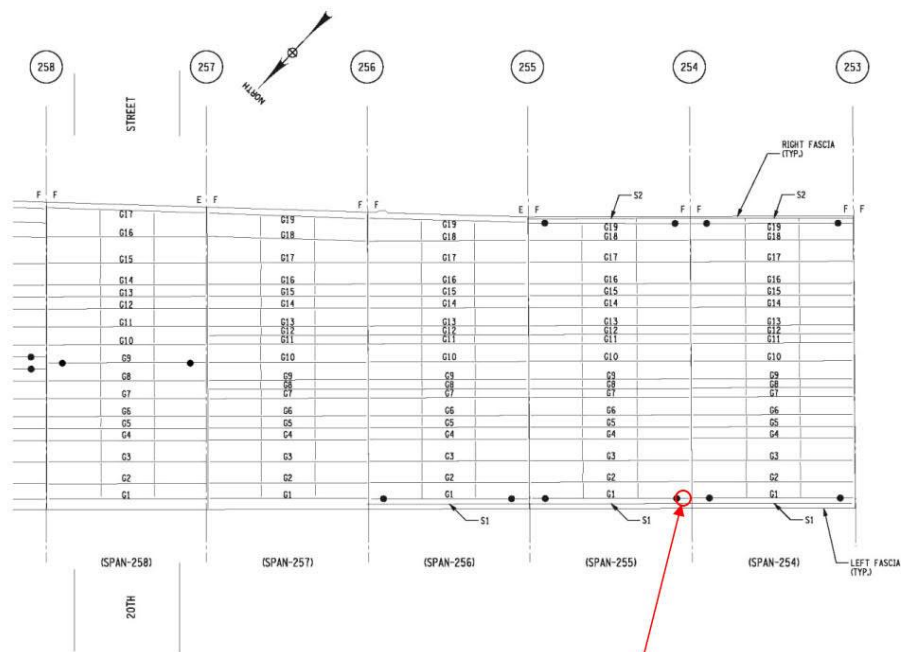
Photo Number: 7

**YELLOW FLAG
LOCATION**
No. NB2222W008

Attachment Description: SN 255 G1 at Pier 254 Framing Plan
